SUITLAND HIGH SCHOOL

FEASIBILITY STUDY

Prince George County Public Schools

7 March 2019

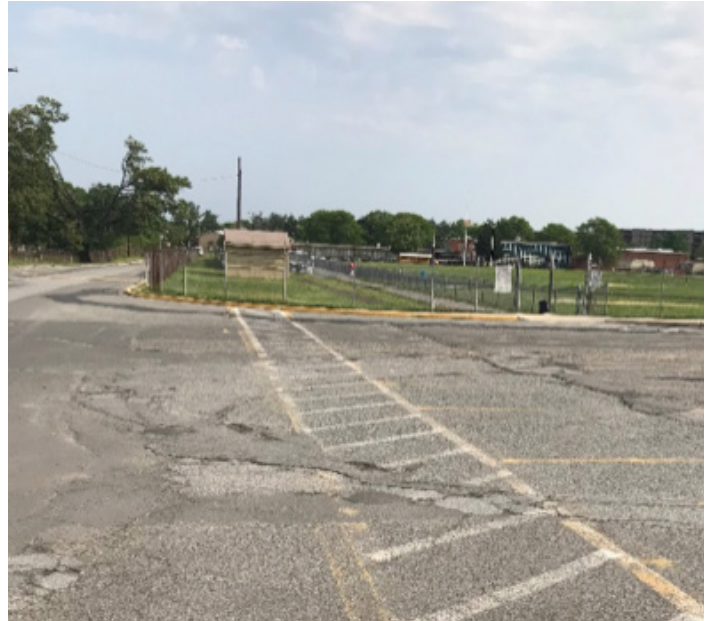
Damaged asphalt

deteriorating. There are many areas in which potholes and standing water exist throughout the pavement surfaces.

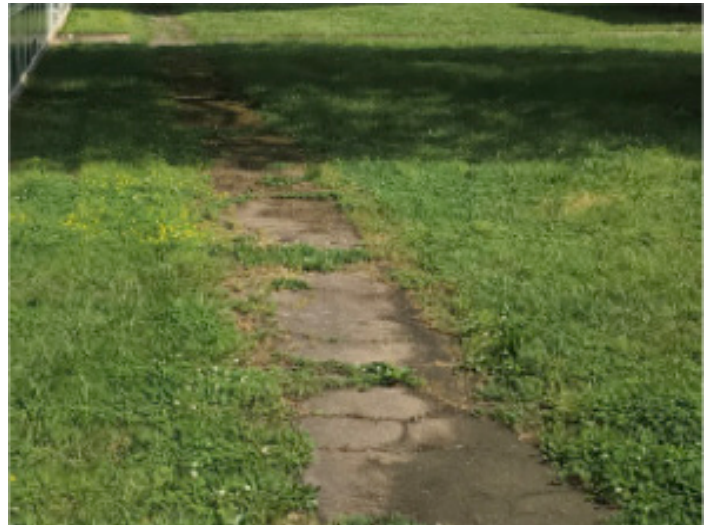
Crumbling sidewalk

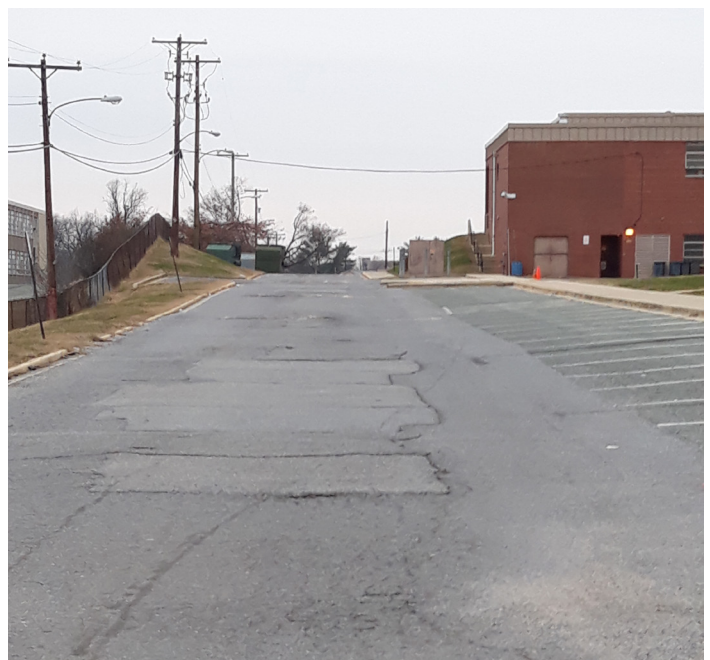
Patching at damaged asphalt

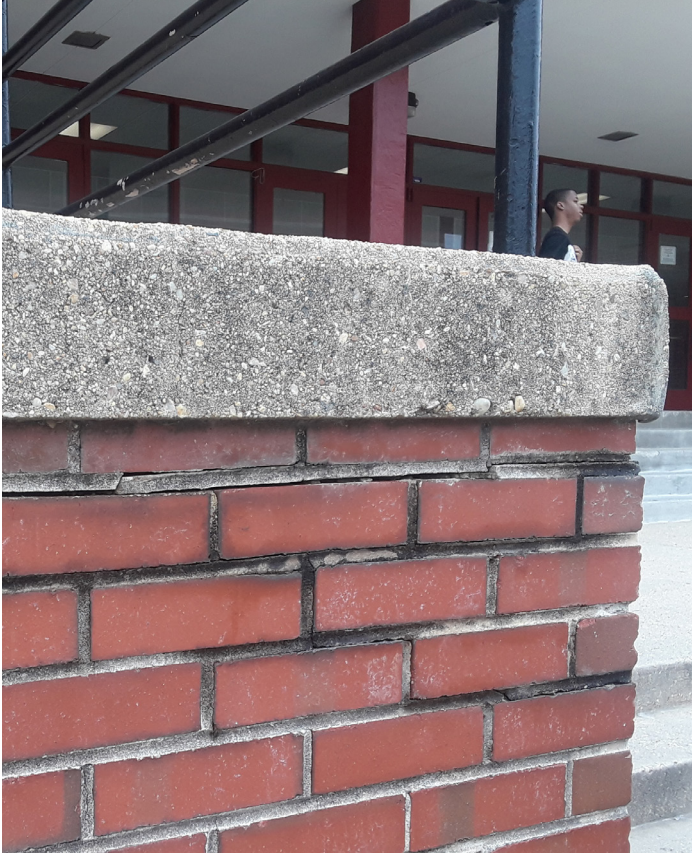
The main entry to the school is at the south of the building. The concrete stair and ramp are in fair condition. There is some deterioration at the concrete and paint is chipping at the railing at the ramp. Concrete steps and slabs at other entries are deteriorated. The other entries lack code compliant railing, steps or ramps. The interior stairs are metal pan and have a vertical metal partition attached to the inside stringer of the stair. A metal handrail pipe is connected to the partition. The stair treads have a VCT covering and a rubber non-slip end. The VCT and rubber ends are chipping off some treads, as well as the paint from the metal pipe handrails. The ramp at the entry of the school provides access to the first floor, but there is no elevator in the building to provide access to the second floor.

Grout damage at entry

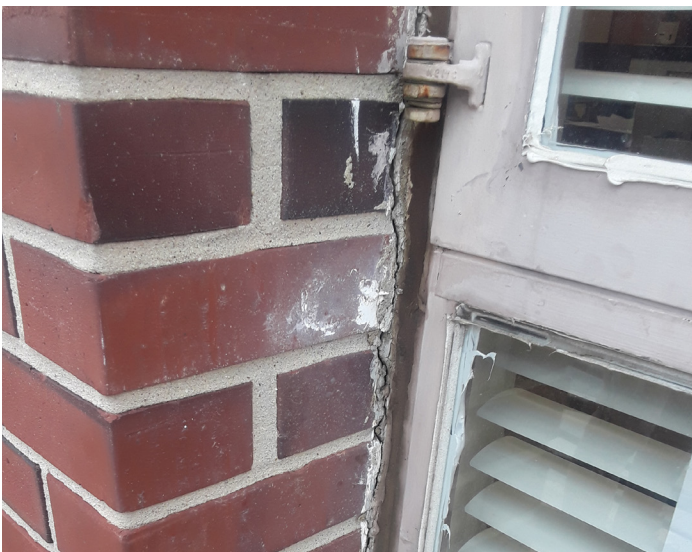
Sealant deteriorating at windows

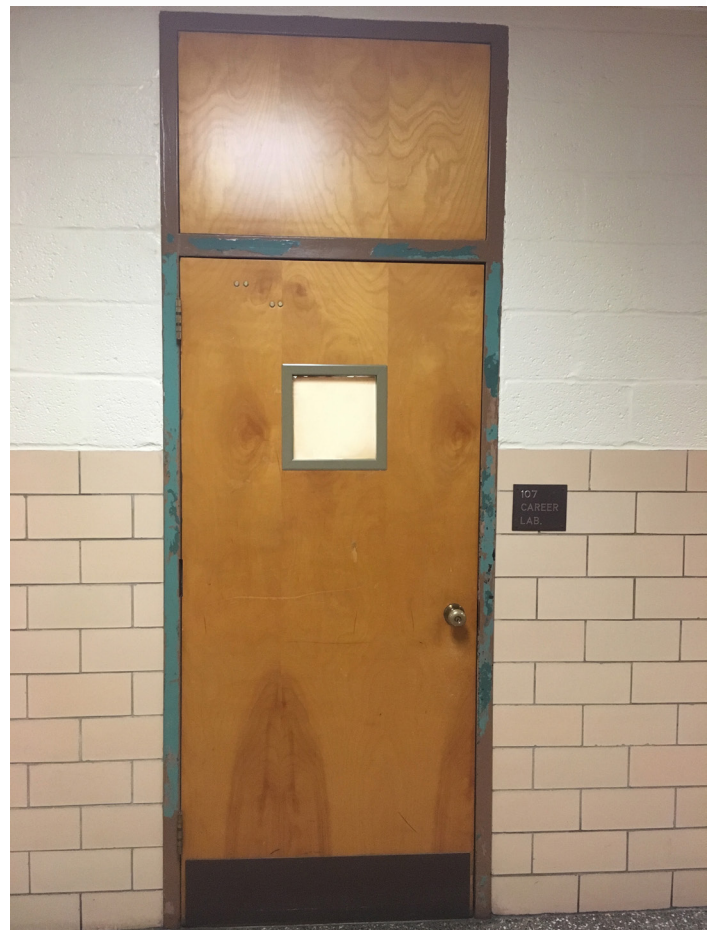
Door hardware and hollow core wood doors are in fair condition. Veneers on some are delaminating and many of the metal frames are in need of refinishing. Classroom entry door hardware is a mixture of levers and knobs. Most are in working condition but knobs are not accessibility compliant.

Typical Door Condition

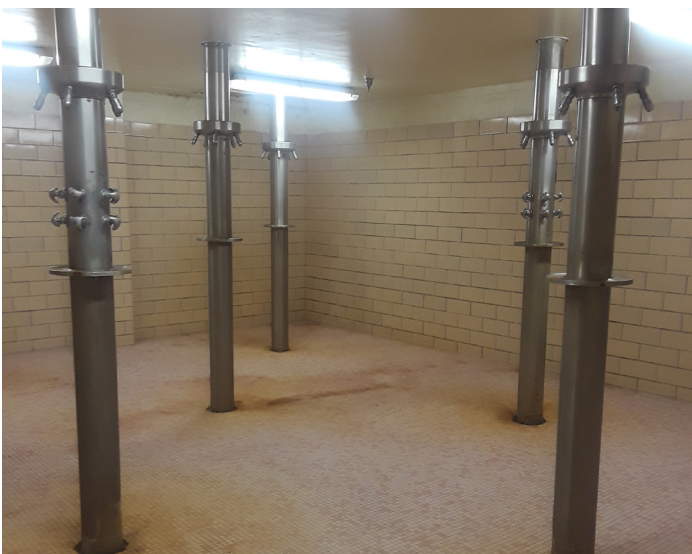
Girls shower area

The girls locker room has tile flooring throughout. The shower area is in fair condition but is not accessible. The floor mounted benches in the locker area are in good condition. The girls locker room has an aisle clearance of 6 ft between lockers. The dressing area in the girls locker room has a laminate covered built-in counter that is delaminating. There are both wall mounted and recessed florescent light fixtures in the girls locker room that are in fair condition

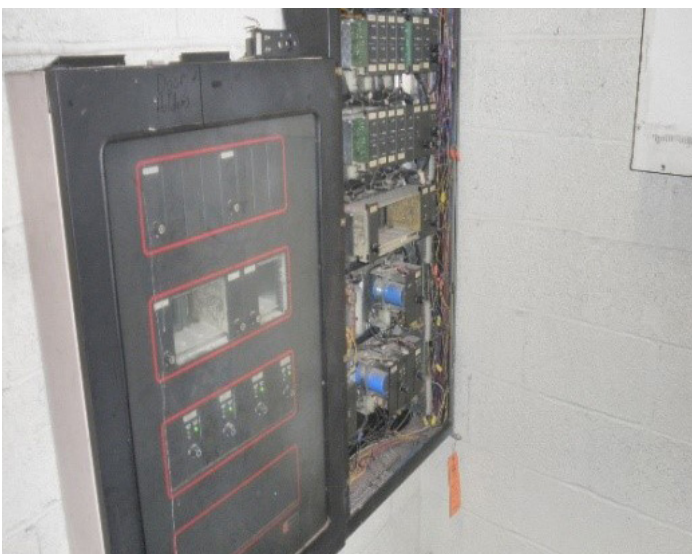
FACP in electrical room

Fire Alarm Control Panel: Wall mounted in the electrical room. FACP is zone based. The existing FACP is provided by Simplex and in fair condition. Installation date was not available from the school official. It is recommended to replace the existing system with the addressable type, which has several advantages, such as easily expandable and includes new technology for the fire alarm system.

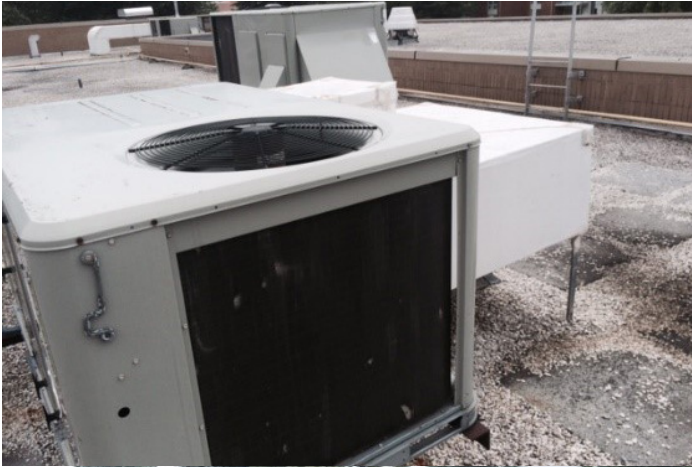
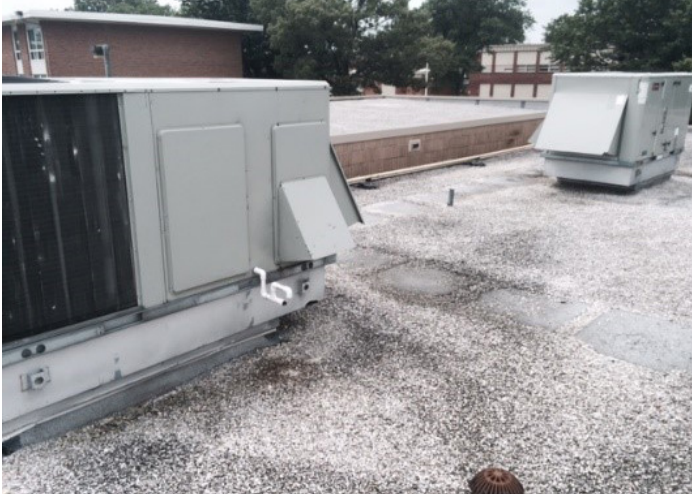
Rooftop units in good condition

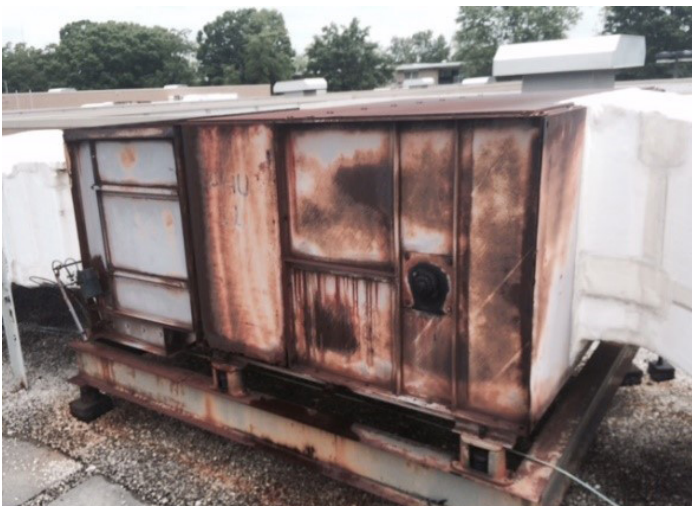
Rooftop Unit in Poor Condition

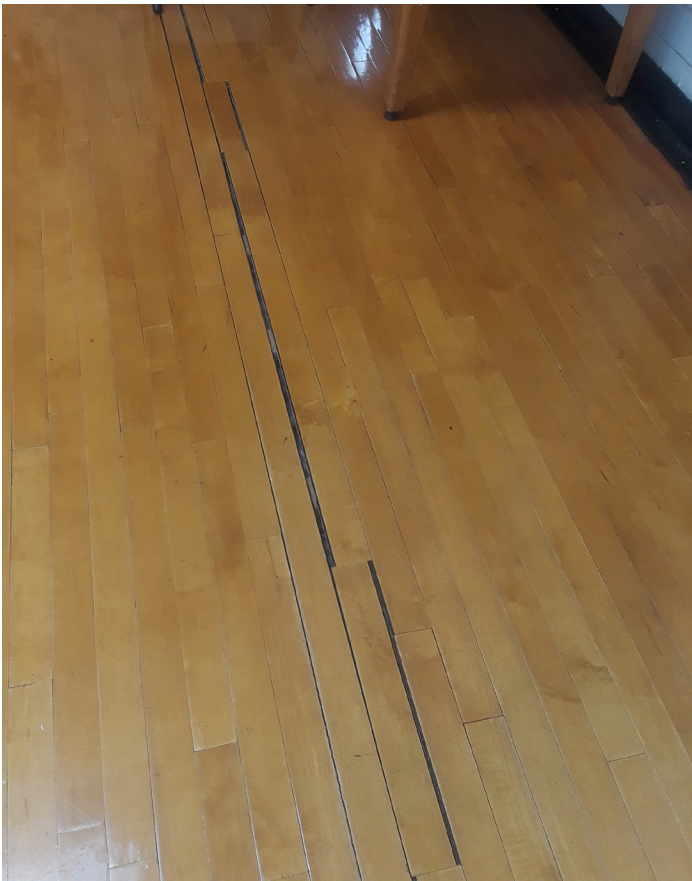
Damaged floor at dance studio

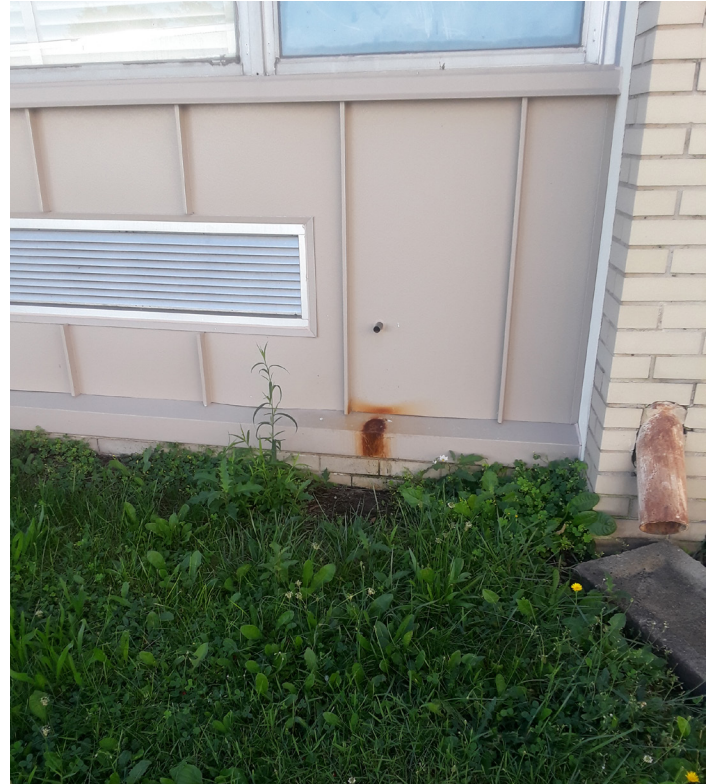
Typical staining at condensate drainage

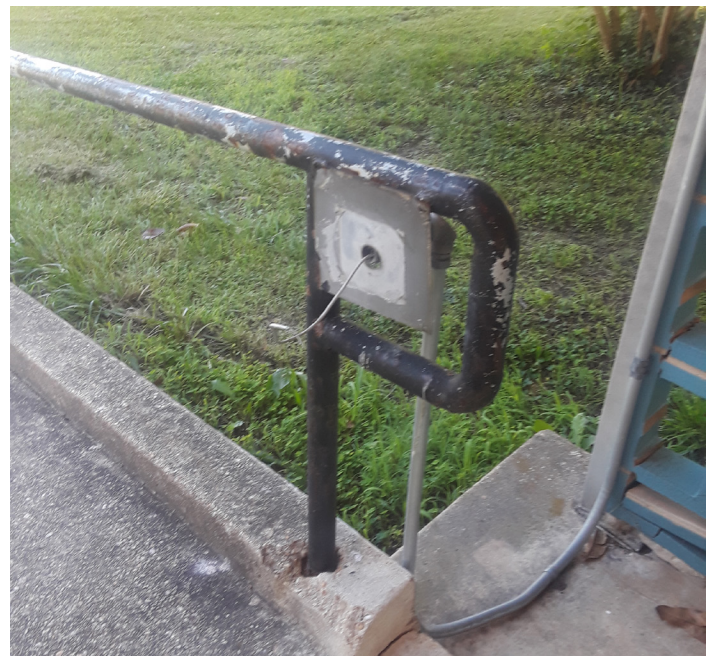
Ramp entry with missing push button

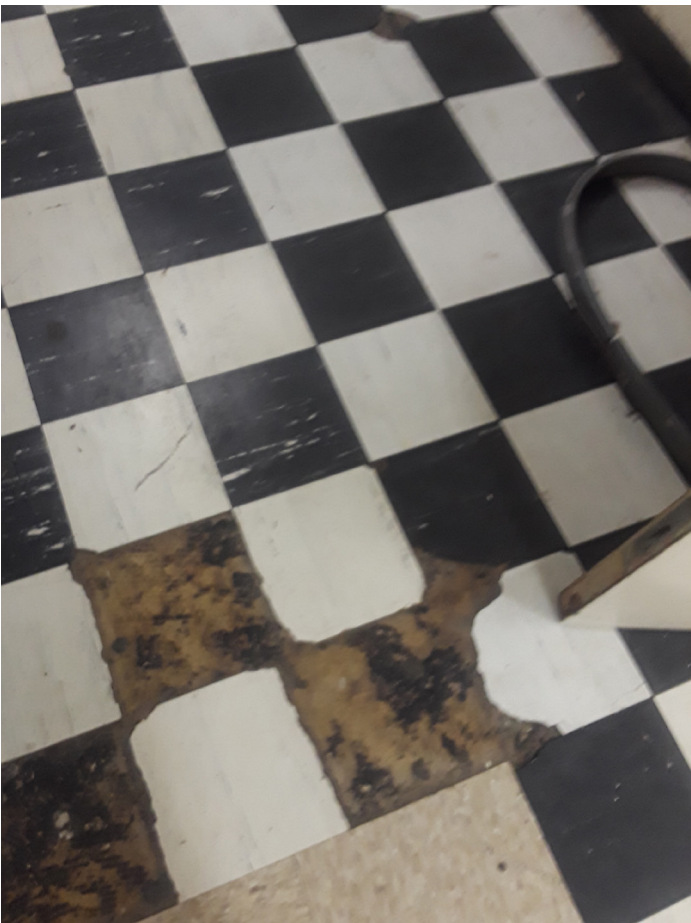
Damaged flooring outside of girls locker room
