**RE: Indoor Air Quality (IAQ) and Mold Assessment Services  
Samuel Chase Elementary School  
5700 Fisher Road, Temple Hills, MD 20748  
Contract No.: IFB 022-19; Tidewater Project No.: 5419-002**

Tidewater, Inc. (Tidewater) is pleased to present this Indoor Air Quality (IAQ) and Mold Assessment Report describing the results of the IAQ assessment and mold survey conducted by Tidewater at Samuel Chase Elementary School located at 5700 Fischer Road in Temple Hills, Maryland. The IAQ and Mold survey was conducted on May 16, 2019, by Tidewater's Project Manager and Certified Industrial Hygienist, Mr. Skanda Abeyesekere MS, CIH, CSP, CHMM.

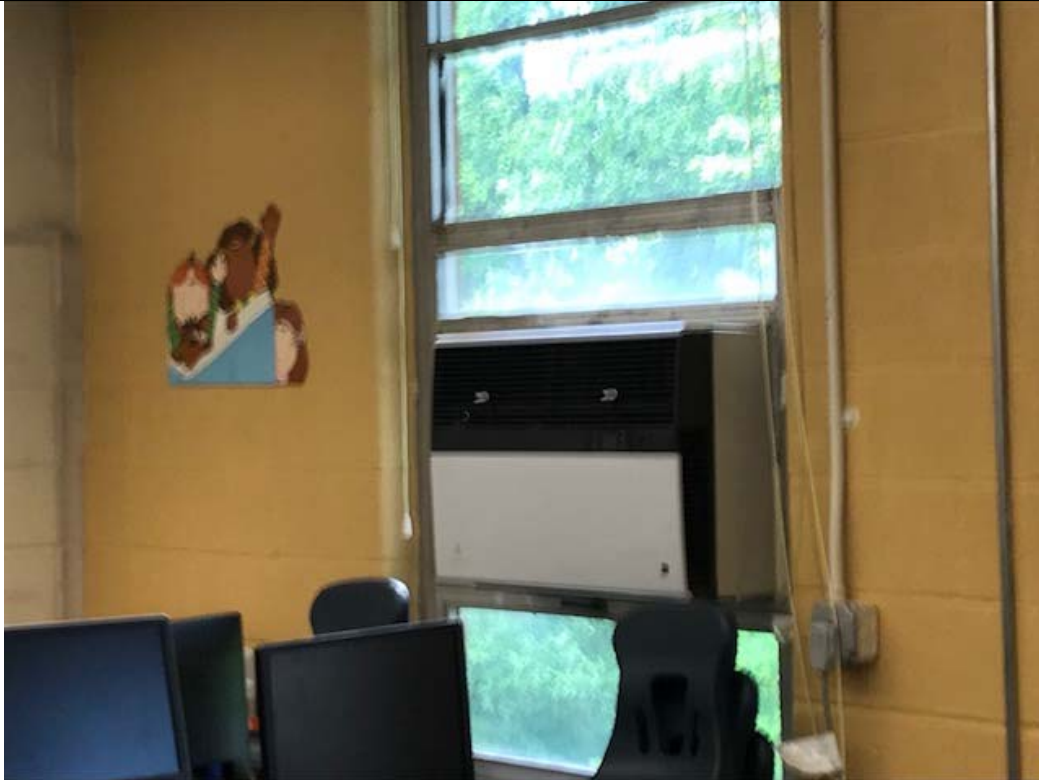
Library was vacant at the time of the inspection. The return air grills located on the ceiling appeared to be clean and free of dust. A window-mounted air conditioning unit was in operation at the time of the inspection. No signs of mold growth or past or ongoing water-intrusion problems were observed in the Library. No odors were detected from the Library. General housekeeping can improve.

**Photo 1:** Library – Wall Mounted Air Conditioning Unit.

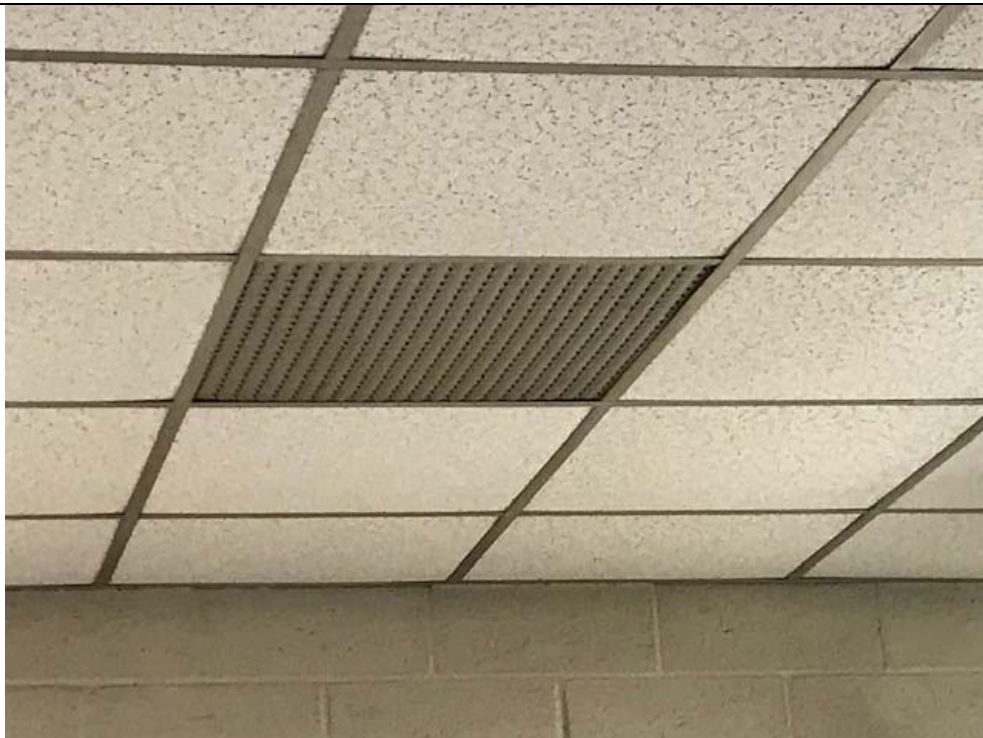
**Photo 2:** Library – Ceiling mounted air grills clean and free of dust.

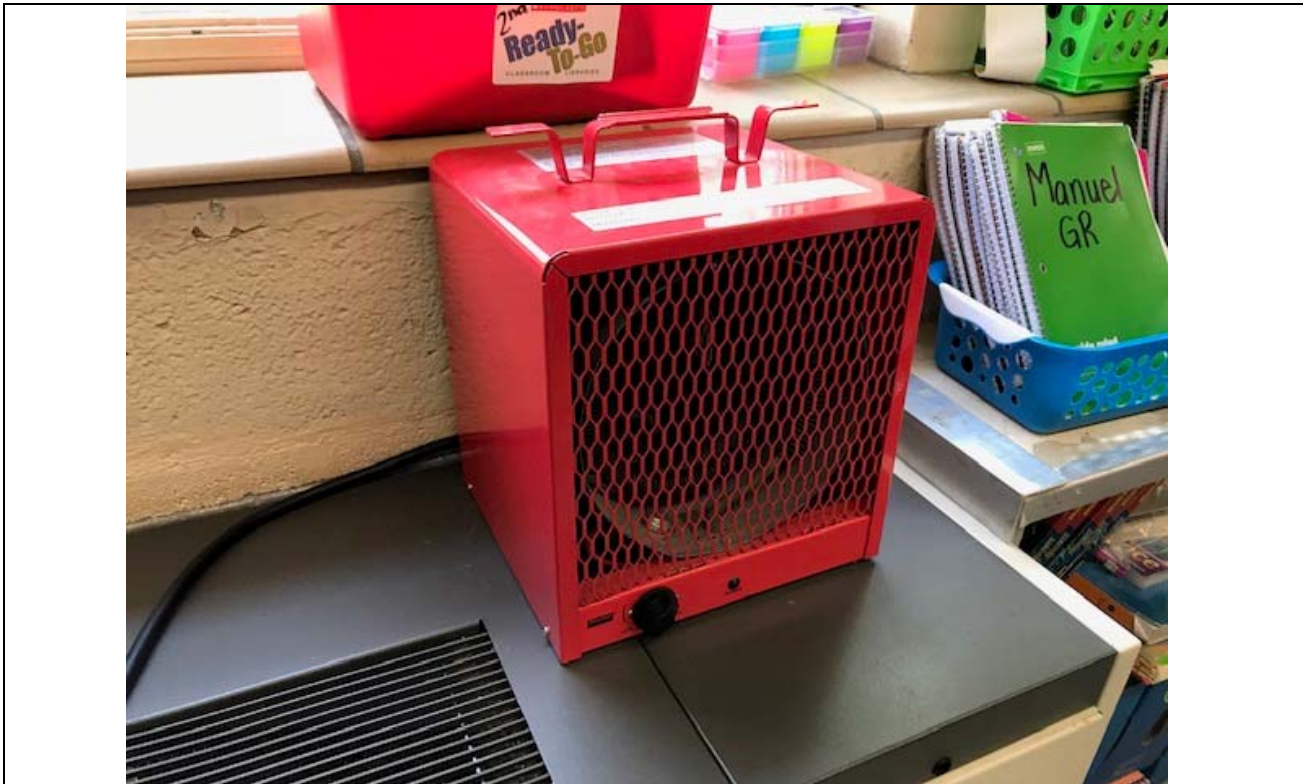
Approximately 20 students were in classroom 105 at the time of the inspection. A window-mounted air conditioning unit was in operation. A wall-mounted fan coil unit was also observed in the classroom. This fan coil unit was not in operation at the time of the inspection. A portable heater was also observed in the classroom. No signs of mold growth or past or ongoing water-intrusion problems were observed. Furthermore, no odors were detected from the classroom.

**Photo 3:** Classroom 105 – Portable Space Heater.

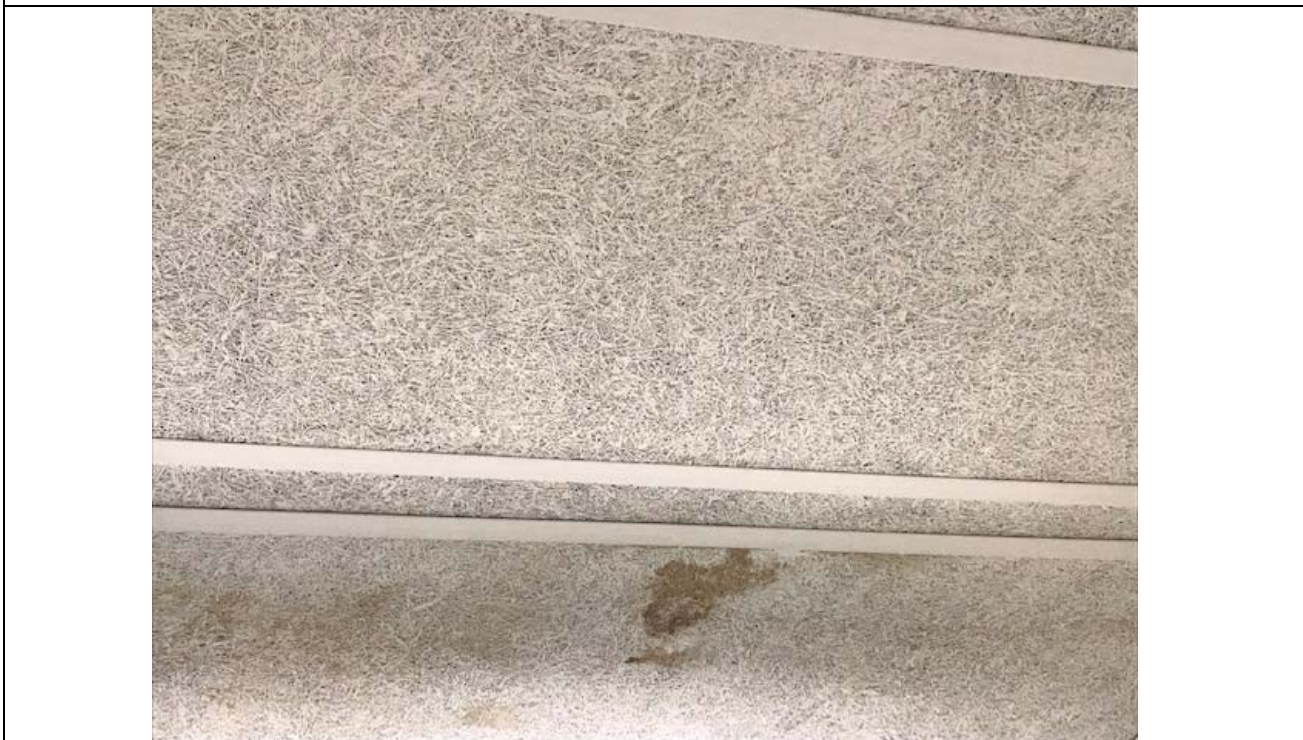
Approximately 15 students were in classroom 101 at the time of the inspection. A window-mounted air conditioning unit was in operation. A wall-mounted fan coil unit was also observed in the classroom. This fan coil unit was not in operation at the time of the inspection. A water-stained ceiling tile was observed in the classroom. No odors were detected from the classroom.

**Photo 4:** Classroom 101 – Water-stained ceiling tile.

- Investigate above the water-stained ceiling tiles in Classroom 101 and Temporary Building for any ongoing water leaks and surface mold formations. If any leaks are detected, repair them immediately. If surface mold contamination is observed, appropriate steps should be taken to remediate and sanitize the affected areas;

- Remove the water-stained ceiling tiles in Classroom 101 and the Temporary Building. Ensure that the perimeters of the ceiling grids are cleaned with a 10% bleach solution to eliminate exiting fungal spores prior to installing a new ceiling tile;

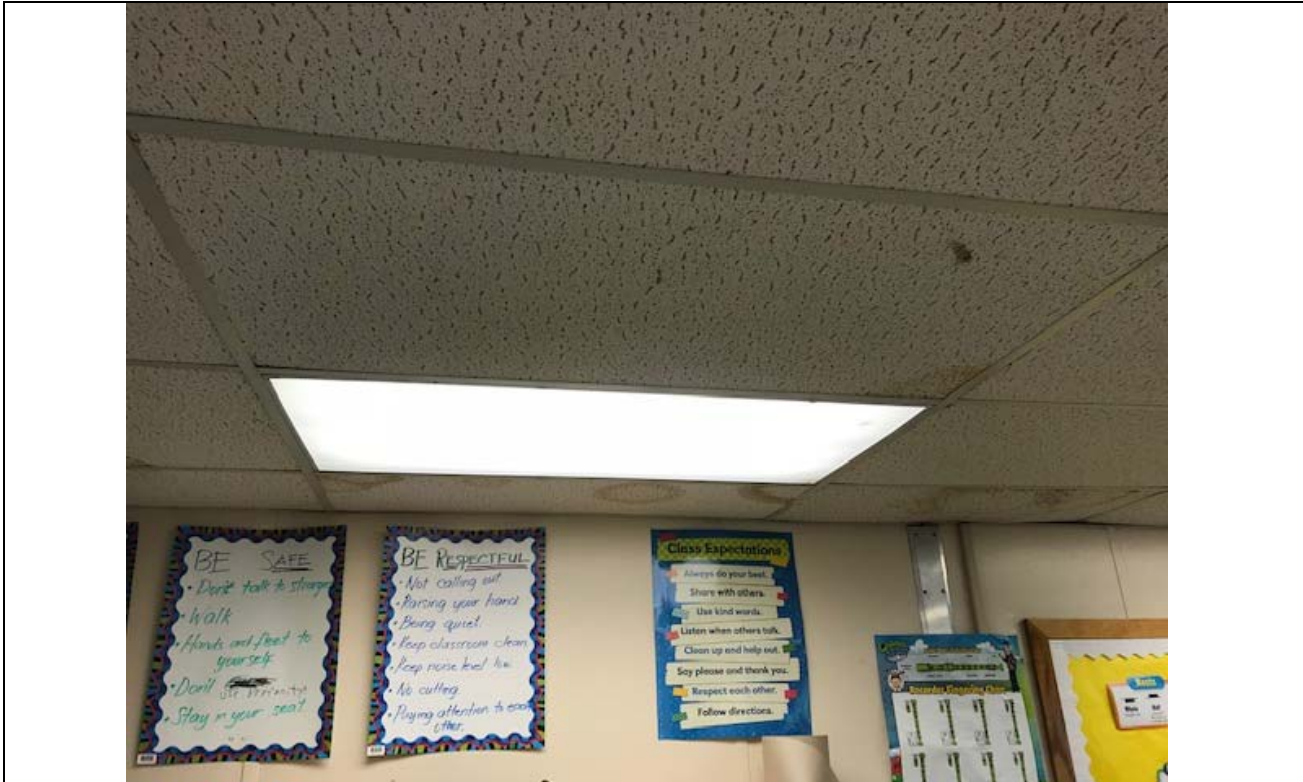
Approximately 20 students were in the temporary building at the time of the inspection. A wall-mounted air conditioning unit was in operation at the time of the inspection. Multiple water-stained ceiling tiles were observed in the building. No odors were detected in the building.

**Photo 5:** Temporary Building: Multiple water-stained ceiling tiles on ceiling.

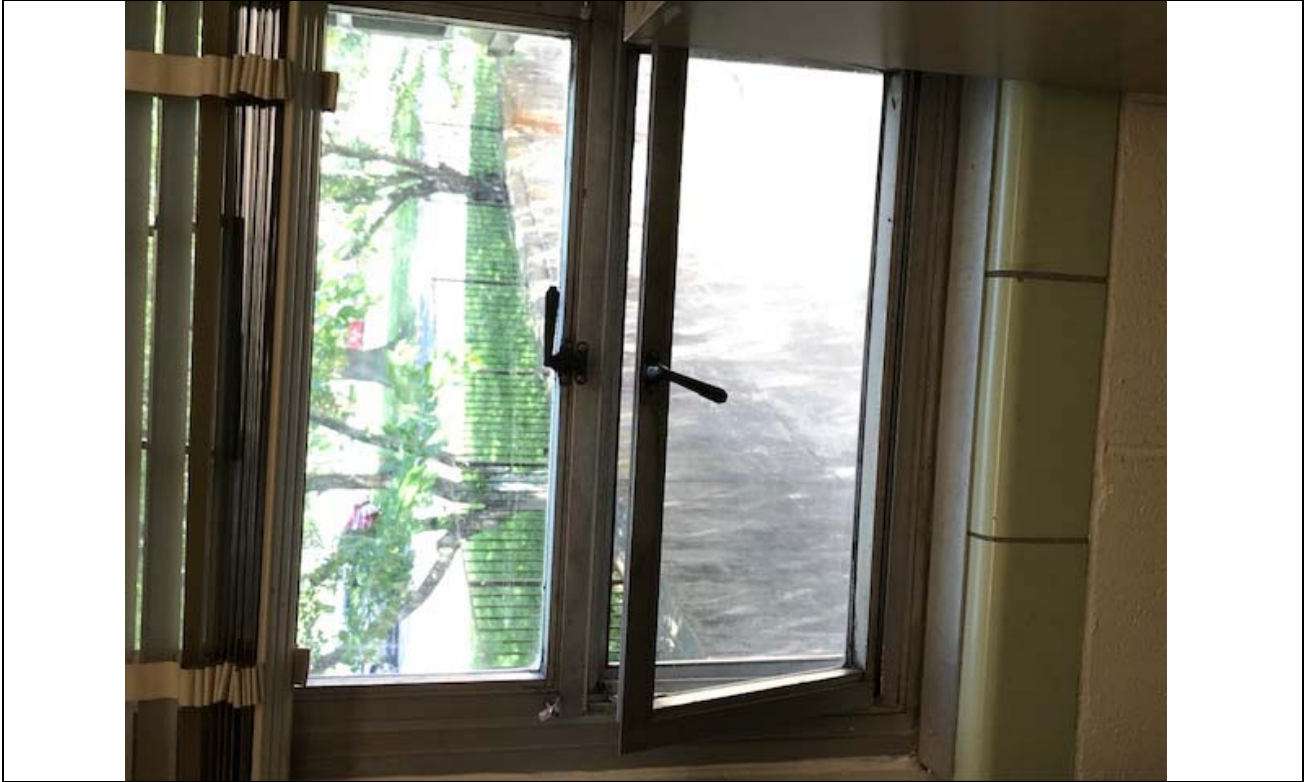
Classroom 21 was vacant at the time of the inspection. A window-mounted air conditioning unit was in operation at the time of the inspection. A wall-mounted fan coil unit was also observed in the classroom. The wall-mounted fan coil unit was not in operation at the time of the inspection and the room was warm. A portable heater was also observed in the classroom. No signs of mold growth or past or ongoing water-intrusion problems were observed. A window was observed to be left opened allowing outside air to enter the classroom.

**Photo 7:** 1<sup>st</sup> Floor Classroom 21 – Window left open.
