**RE: Indoor Air Quality (IAQ) and Mold Assessment Services
Valley View Elementary School
5500 Danby Avenue, Oxon Hill, MD 20745
Contract No.: IFB 022-19; Tidewater Project No.: 5419-004**

Tidewater, Inc. (Tidewater) is pleased to present this Indoor Air Quality (IAQ) and Mold Assessment Report describing the results of the IAQ assessment and mold survey conducted by Tidewater at Valley View Elementary School located at 5500 Danby Avenue, Oxon Hill, Maryland. This survey was conducted on May 20, 2019, by Tidewater's Project Manager and Certified Industrial Hygienist, Mr. Skanda Abeyesekere MS, CIH, CSP, CHMM.

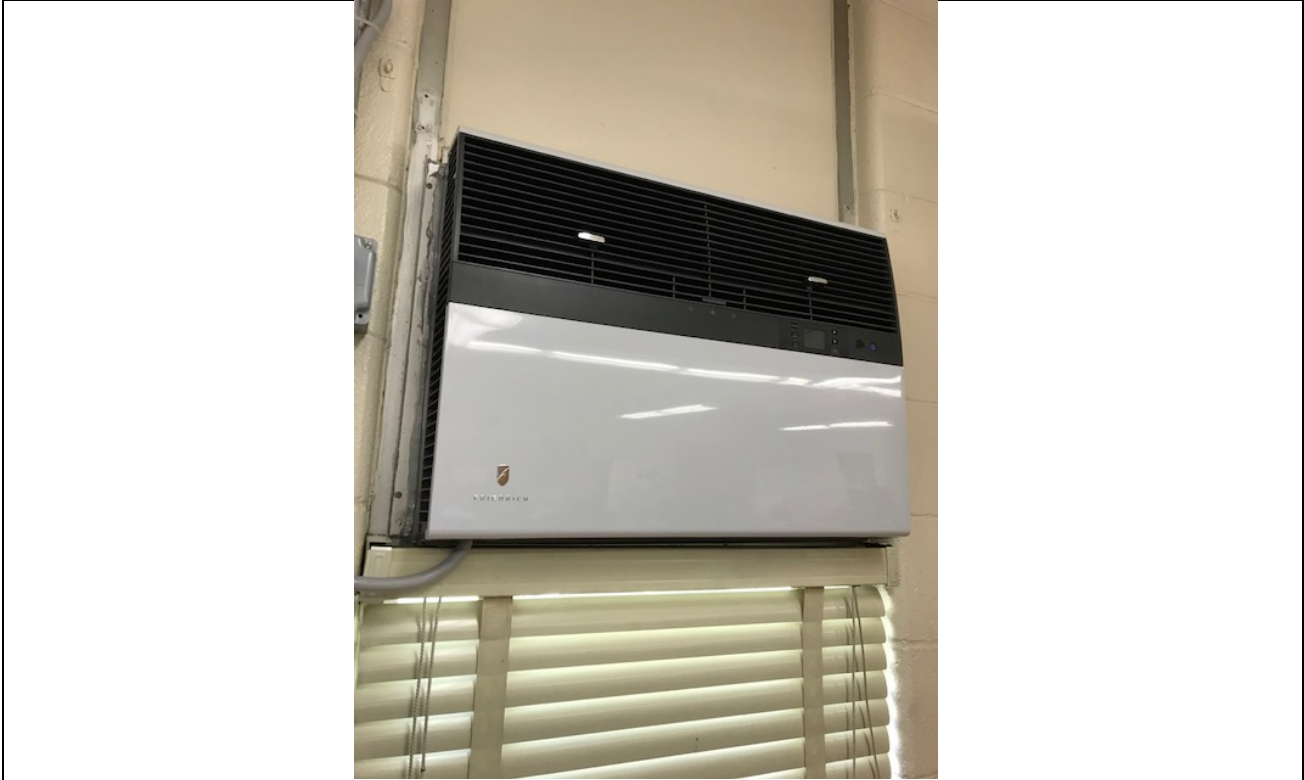
Classroom 15 had around 20 students at the time of the inspection. The window-mounted HVAC unit was in operation at the time of the inspection and the general air circulation was good. A protruding ceiling tile was observed within Classroom 15. General housekeeping within the classroom can improve. No signs of mold growth or past or ongoing water-intrusion problems were observed within the classroom. No odors were detected within the classroom.

Photo 1: Classroom 15 – Window-mounted HVAC system operating.

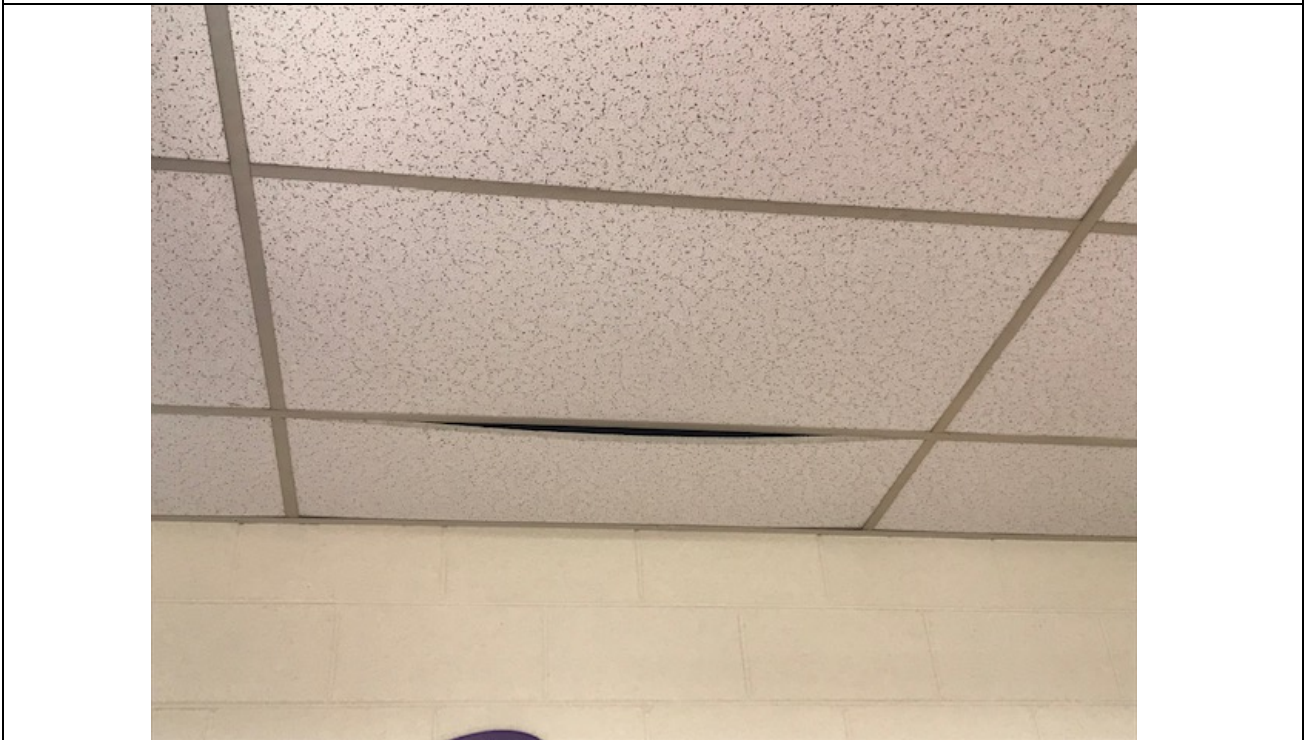
- Tidewater's visual inspection of the Main Office, Classroom 3, Classroom 6, Classroom 11, Classroom 10, Classroom 15, Classroom 20, Classroom 24, Classroom 27 and Library of Valley View Elementary School did not reveal any visible evidence of standing water, active water intrusion on the walls, floors or ceiling in any of areas inspected. However, dust and mold formations were observed on the supply grills of the window-mounted HVAC units in Classrooms 10, 11, 20 and the Library. General housekeeping in all classrooms can be improved. A protruding ceiling tile was observed in Classroom 15.

Photo 2: Classroom 15 – Protruding Ceiling Tile.

- Ensure that all cleaning activities are conducted after hours when the classrooms are vacant to minimize exposure to occupants;
- Replace the protruding ceiling tile in Classroom 15;

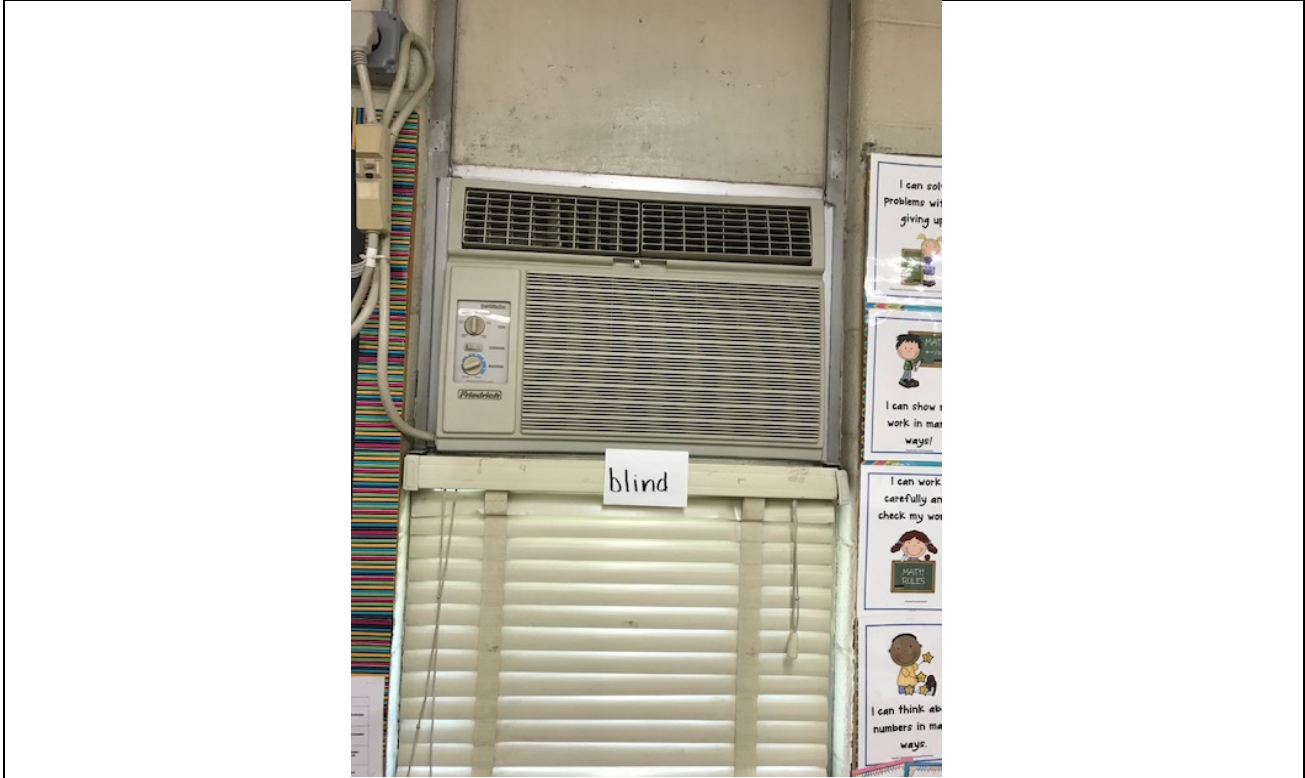
Classroom 20 was vacant at the time of the inspection. The HVAC unit was not in operation at the time of the inspection. Furthermore, the supply air grills of the HVAC system were dusty. General housekeeping within the classroom was good. No odors were detected. No signs of mold growth or past or ongoing water-intrusion problems were observed.

Photo 3: Classroom 20 – Window Mounted HVAC Unit with dusty grills

- Clean all supply/return air grills of the window-mounted HVAC units in all Classrooms particularly in Classrooms 10, 11, 20 and Library with a 10% bleach solution to eliminate mold formations;

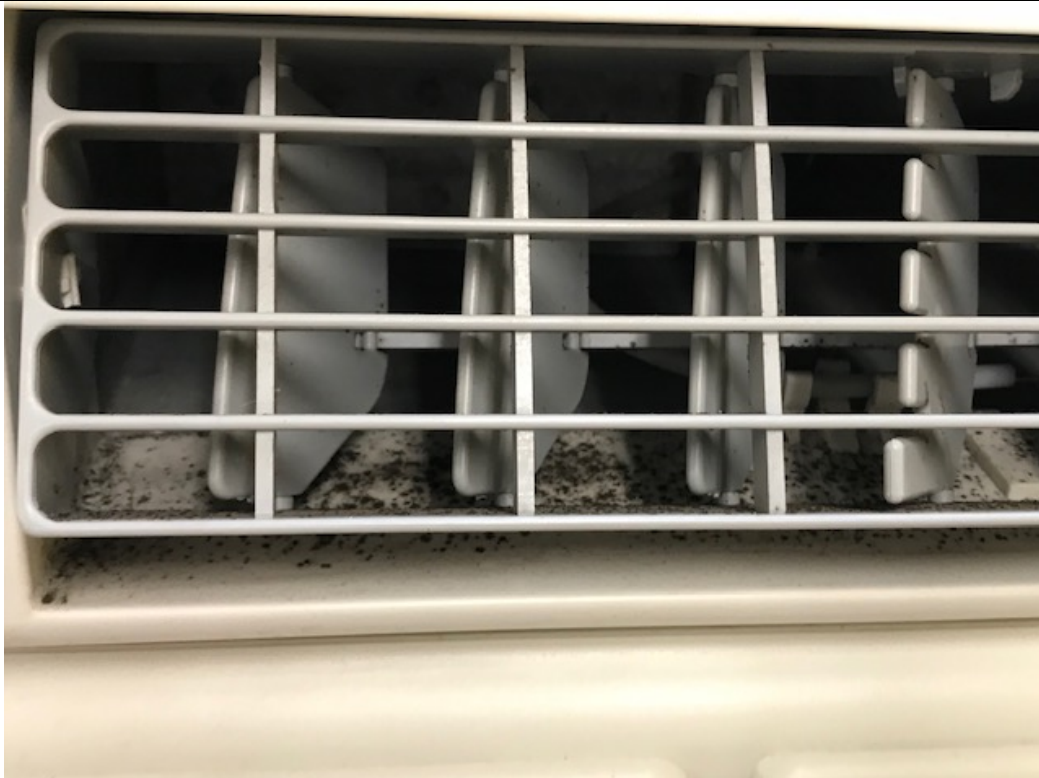
Classroom 10 had around five (5) occupants at the time of the inspection. Two (2) window-mounted HVAC units were in operation at the time of the inspection. The air supply grills of the window-mounted HVAC units contained visible mold formations. General housekeeping within the classroom can improve. No signs of mold growth or past or ongoing water-intrusion problems were observed. No odors were detected within classroom 10.

Photo 5: Classroom 10 – Window-mounted air conditioning unit with mold infested return grills

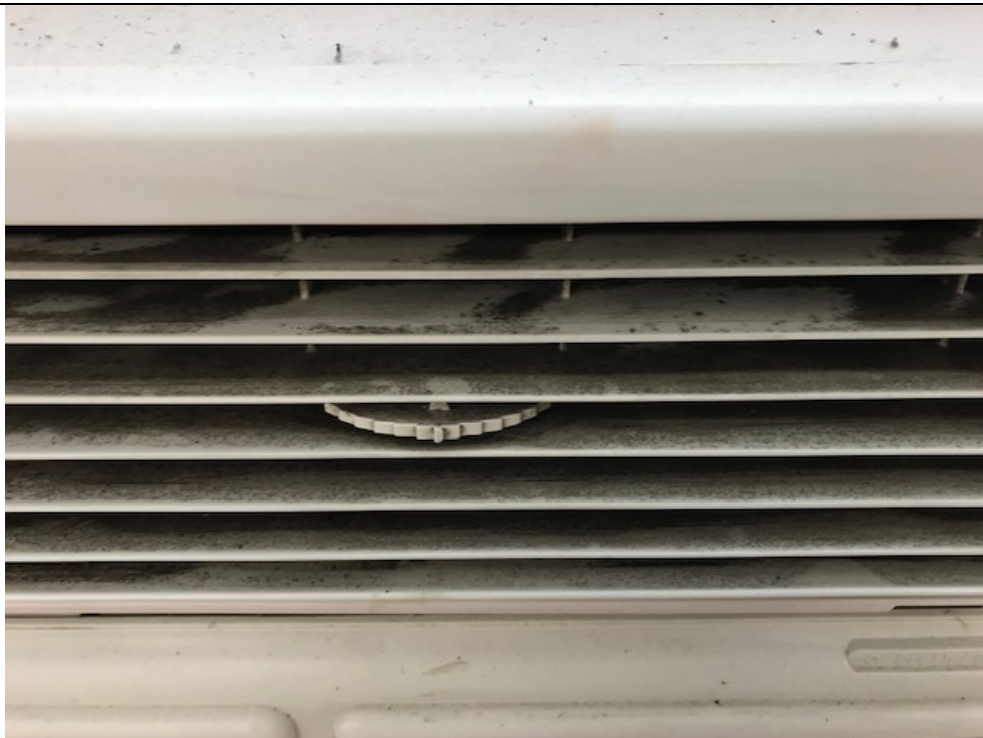
Library was vacant at the time of the inspection. Several window-mounted air conditioning units were in operation at the time of the inspection and general air flow within the Library appeared to be good. The supply grills of the wall-mounted HVAC units contained mold formations. No signs of mold growth or past or ongoing water-intrusion problems were observed within the Library and no odors were detected.

Photo 6: Library – Window-mounted air conditioning unit with mold infested return grills
