SUITLAND HIGH SCHOOL

FEASIBILITY STUDY

Prince George County Public Schools

7 March 2019

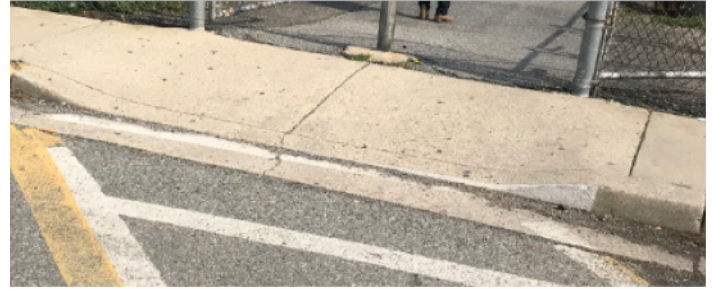
There are several locations throughout the site that do not comply with ADA requirements. Specifically, some paths exceed the cross slope of two percent, handrails are missing on ramps steeper than five percent, and there is a lack of proper landings on some of the ramps.

Existing sidewalk not ADA compliant

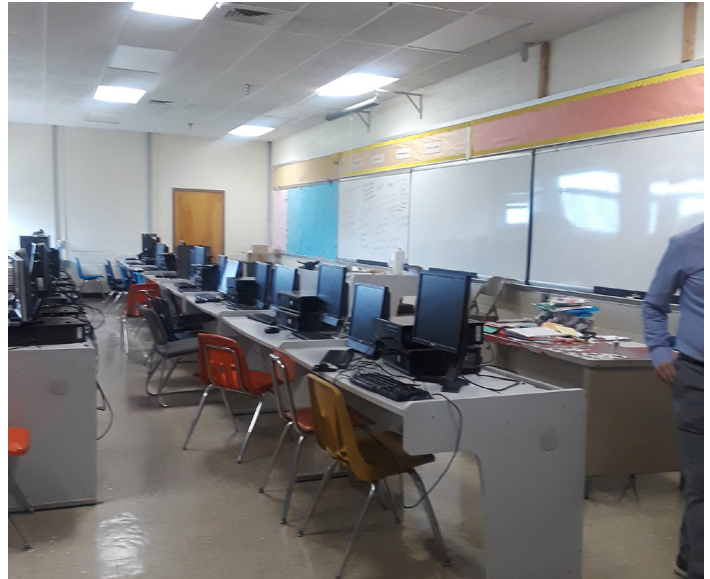
Computer Classroom

Typical classrooms have VCT flooring that is in fair condition and some science classrooms have newer resilient flooring that is in good condition. 2x4 acoustical ceiling tiles show signs of water damage or have been soiled with dust and debris. In general classrooms with built-in casework, the casework is dated but sturdy. Metal cabinets for baseboard heaters show signs of deterioration with rust and chipping paint. Science labs are in good condition, though current trends in science education may necessitate changes in classroom layout and equipment.

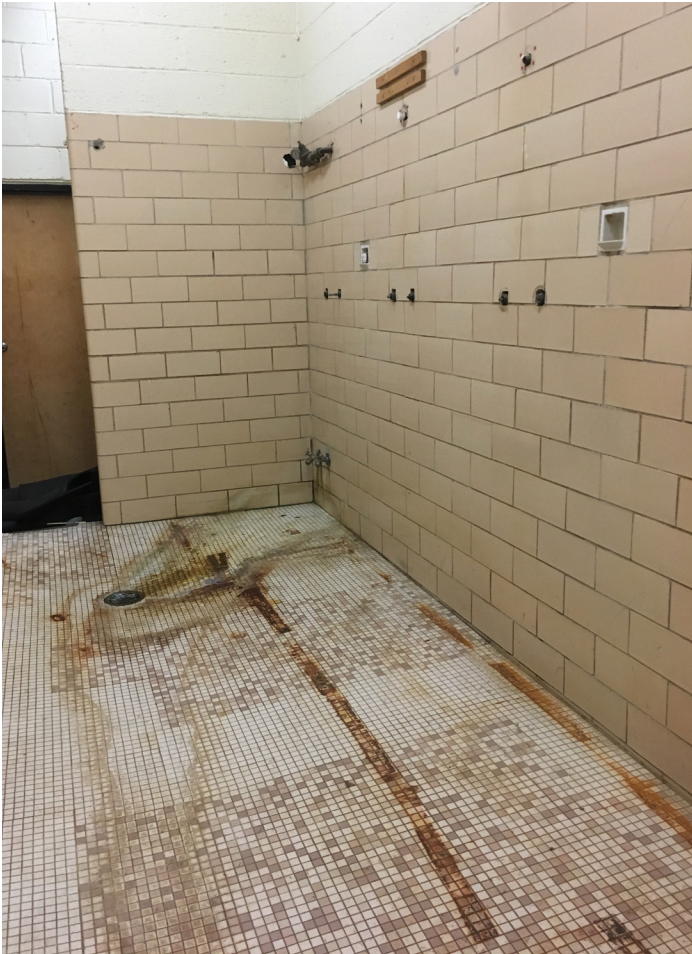
Boys locker room

The boys locker room flanks the main gym. Lockers and concrete floors in the changing area are in good condition. The two shower areas that serve the boys locker room are in poor condition. All plumbing fixtures have been removed from one of the shower areas and the floor is in extremely poor condition. The operable shower area has tile flooring in fair condition. The shower area is raised 10” above the main floor and is not wheelchair accessible. There are no benches in the boys locker room, and the aisles separating the lockers have a clear space of 38 inches .

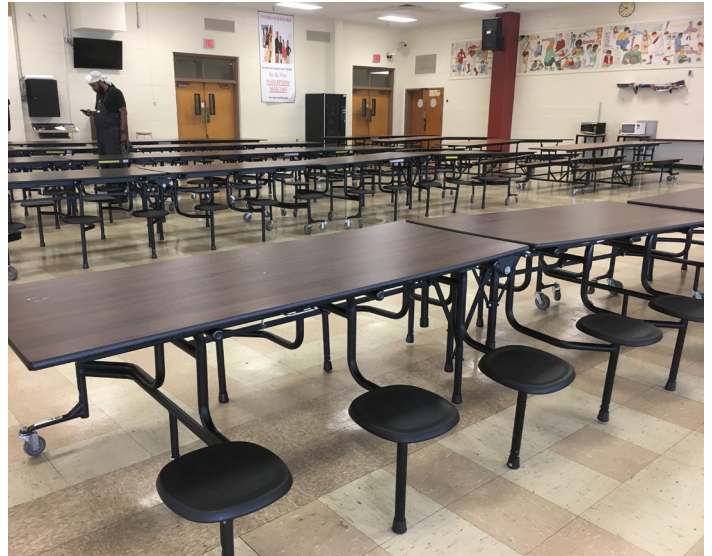
Cafeteria

integral seating found in the cafeteria. The first is a 5 ft long table with individual seating on each side. The second is 6 ft 2 in long with benched seating on each side. The VCT flooring shows signs of deterioration at entries and doors all show signs of extreme wear. There are two serveries at the south end of the cafeteria with the kitchen to the south of the serveries. In addition to the main food preparation area, there is a storage area, office and women's only restroom. The kitchen is spacious and the equipment appears to be in working condition. VCT flooring also appears to be in fair condition.

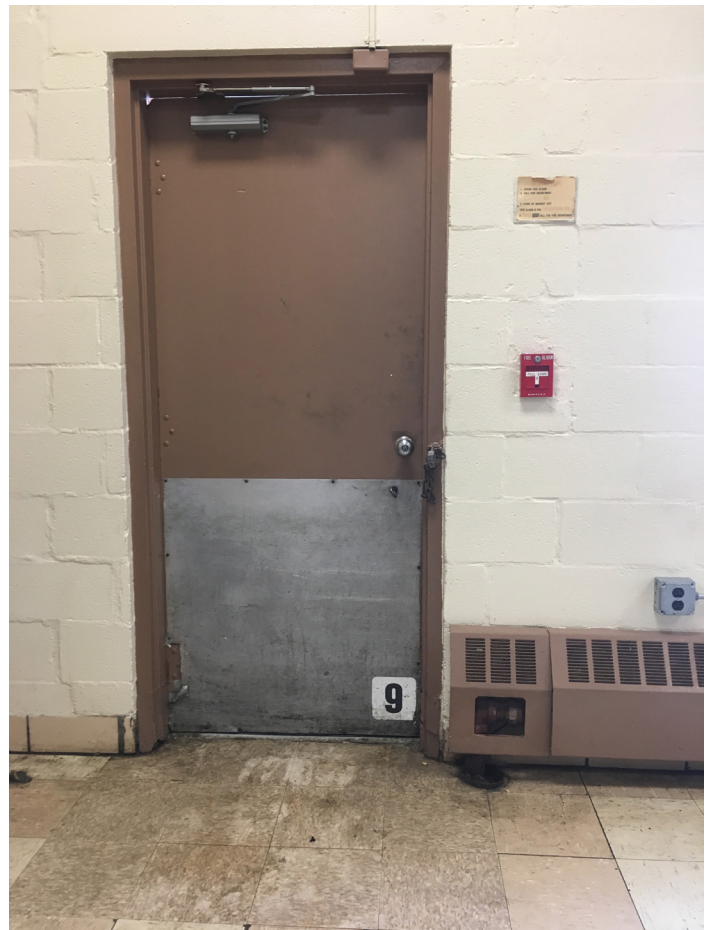
Exterior door in cafeteria

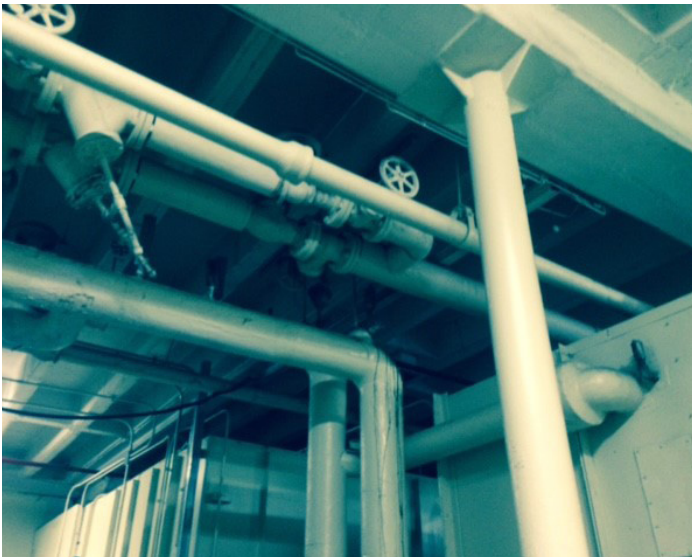
The East side of the second floor and most of the first floor is served by 2 large air handling systems which appear to be field assembled. The air handlers consist simply of a draw through supply fan, chilled water coil, steam preheat coil, filter section and mixing box. They are located in mechanical rooms on the first and second floor as shown and serve the East side of both floors of the building. The units provide ventilation and cooling in the warm season. They draw air through large louvers on the side wall of the mechanical rooms. They are equipped with steam reheat coils to temper air in the winter. The units do not have frequency drives or modulating inlet dampers. The areas they serve only have thermostats for the perimeter heat. The individual rooms these serve have no terminal units therefore, it appears that the cooling is done by return air temperature and does not have any individual control. There is no heat recovery. The built-up air handling units appear to be at least 20 years old. Though they are serviceable and appear to be well maintained, they are ready for replacement.

Typical Built up AHU on 1st and 2nd floor

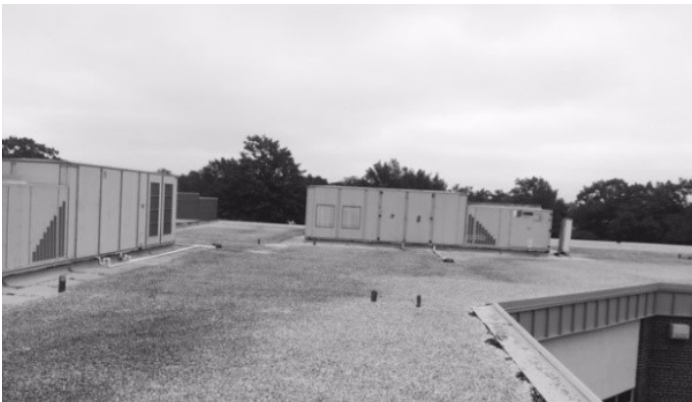
Rooftop Units

TRANE model SAHFF50 nominal 50-ton units. All units are identical in configuration. They have no heat, no VFD or modulating inlet dampers therefore these units are similar to the existing air handlers in that there is no individual space control and heat is provided by the perimeter radiation units. The units are controlled by return air temperature. These units provide both cooling and ventilation. There is no heat recovery. The units are five years old and appear to be in very good condition.

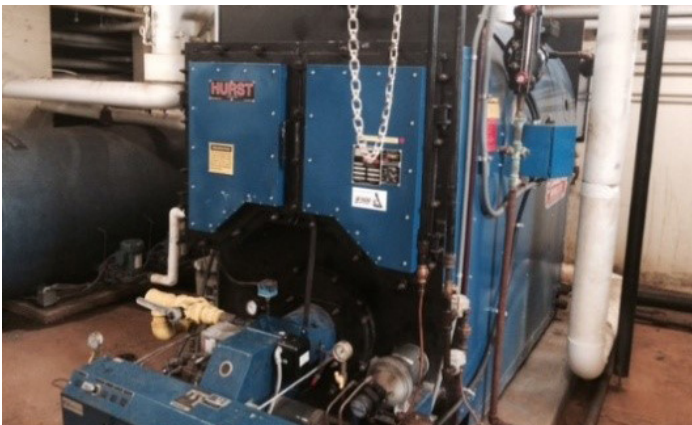
Firebox boilers in north boiler rooms

Heating Plants: Steam for the entire building is provided by dual fuel Fire box steam boilers located in two mechanical rooms, as shown. The north Mechanical room contains two dual fueled 4,226 MBH Fire Box boilers and associated boiler feed units. The south mechanical room contains three 3,650 MBH HB Smith Cast Iron boilers and associated boiler feed units. The boilers feed all of the heating in the building through a two-pipe distribution system. The boilers in the North mechanical room were installed seven years ago and appear to be in very good condition. The boiler feed unit appears to have been installed at the same time as the boilers. The cast iron boilers are in decent working condition. The steam piping in the building dates back to the original building construction and appears to be experiencing numerous leaks.

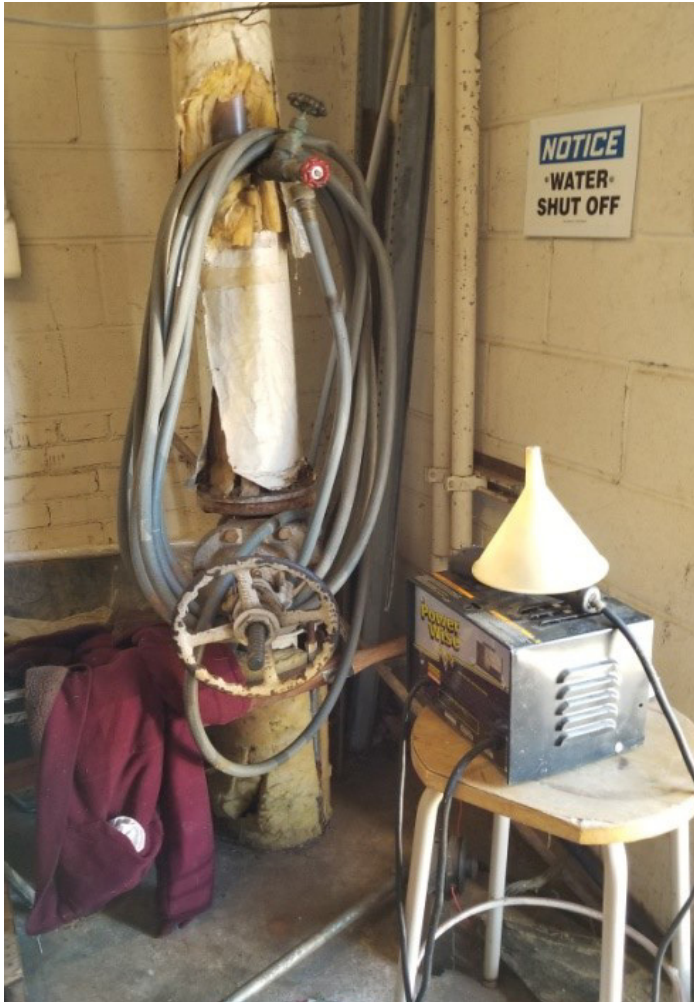
Domestic water and fire protection combined water service is from the city main at Silver Hill Rd. A water meter vault is located at the main water service on the site. The vault is full of water and a backflow preventer is not found installed at school water main. The school water main distributes domestic / fire water supply to each building without a backflow preventer inside the building. It does not meet the current code and local water authority requirement. Backflow preventer has been provided at boiler room mechanical makeup water line connection. It passes through a Reduced Pressure Zone Assembly with the backflow device discharging to the boiler room floor.

Domestic water & fire service in mechanical room

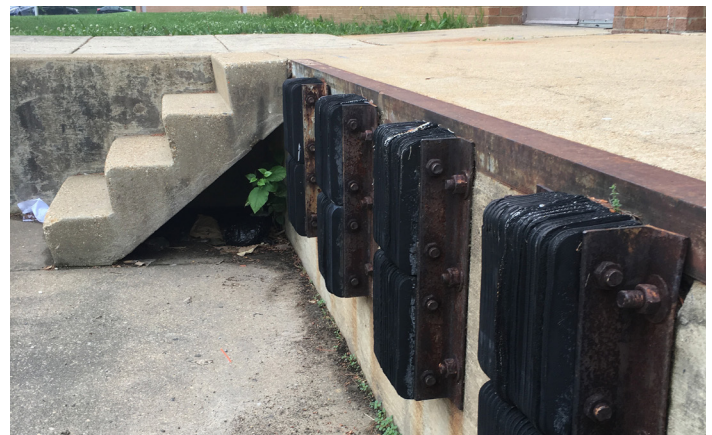
The Annabelle E. Ferguson auditorium was constructed in 1986 and is a free standing building located at the entrance of the high school. A metal canopy covers a walkway located along its western façade. There are murals painted on the brick veneer of the buildings western façade. The storefront assembly at the entry is in fair condition, with some sections pulling apart from expansion and contraction. The storefront frame, doors and metal side panels appears to have been painted black. Door hardware is in poor condition. Clerestory windows atop flush steel entry doors are in need of repaired or replacement. The loading dock and platform on the eastern side of the auditorium has a clogged drain, no overflow drain and the bumper pads at the end are rusting and deteriorating.

Bumpers at loading dock

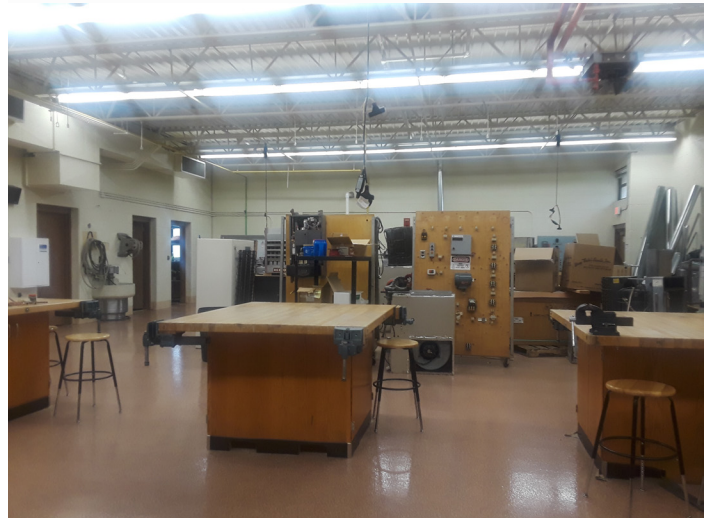
Typical CTE workshop

A typical CTE classroom is a large, double height industrial open space with a metal decking above exposed steel joists, lighting and ductwork. Classrooms are entered through a narrow hallway flanked by lockers which leads to the main space. The VCT in the hallway is in good to fair condition. Some floor patches are stained and need to be replaced. There is a more conventional teaching space, with a much lower ACP ceiling, adjacent to the main classroom space, as well as a storage room and a single use bathroom. Hollow metal doors to bathroom and storage rooms are in fair condition, but door hardware is not accessibility compliant. The main industrial space has resilient flooring. In some spaces the flooring is new. In spaces with older flooring the condition is fair to poor.

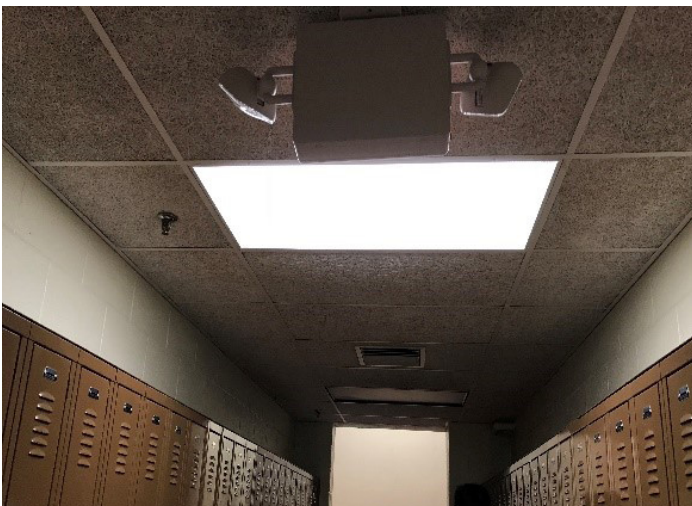
Classrooms/Corridors/Cafeteria/Offices: 2x2 and 2x4 recessed ceiling fixtures with prismatic lens and four T8 fluorescent lamps. Higher energy efficient LED light source are available and upgrade is recommended.

Existing 2x4 recessed fluorescent fixture

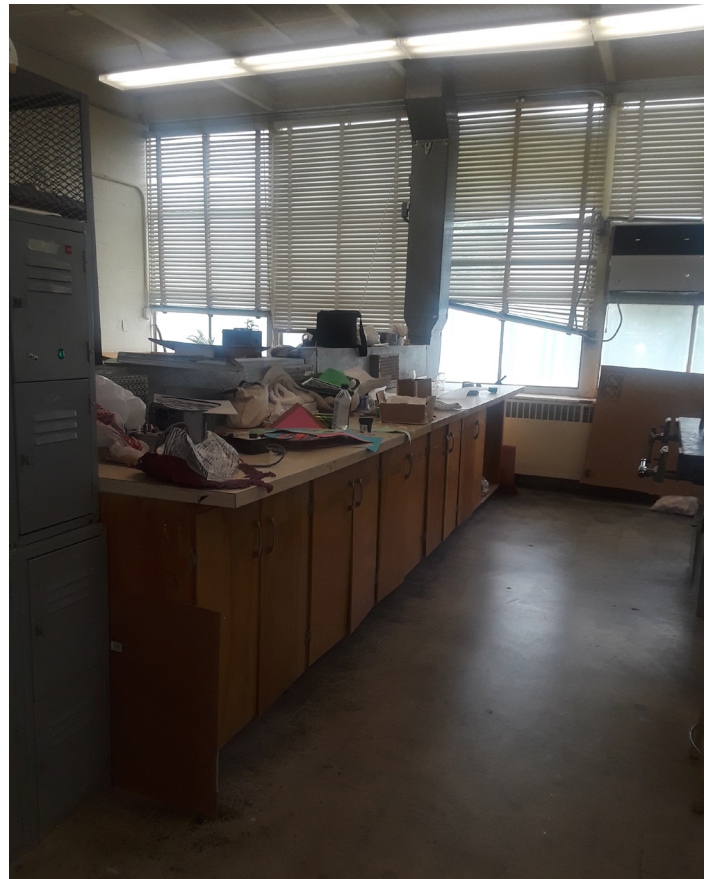
Typical visual arts class

Most classroom have VCT that is in fair condition. Some visual arts classes have sealed, unpainted concrete floors that are also in fair condition. There is a general lack of storage in all classrooms and classroom furniture is in poor condition. The visual arts

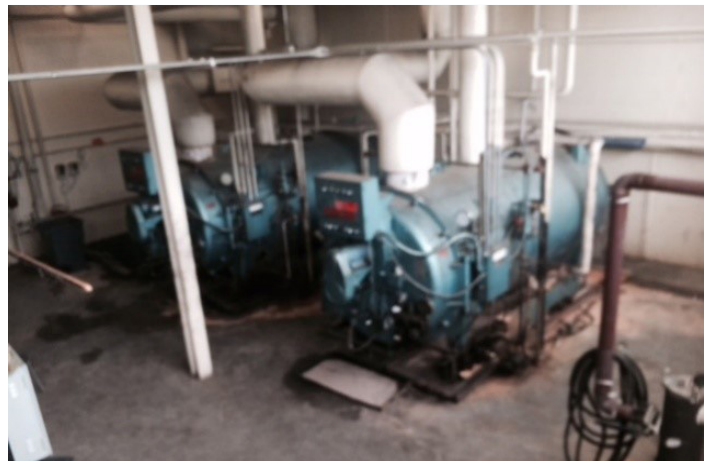
Firetube steam boilers

The existing boilers and boiler feed units appear to have been there at least ten years but they look to be in good condition. There are no recommendations for this system other than routine maintenance.

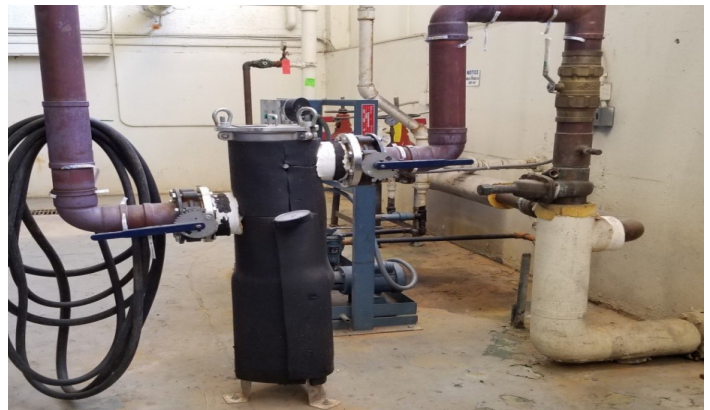
Water service

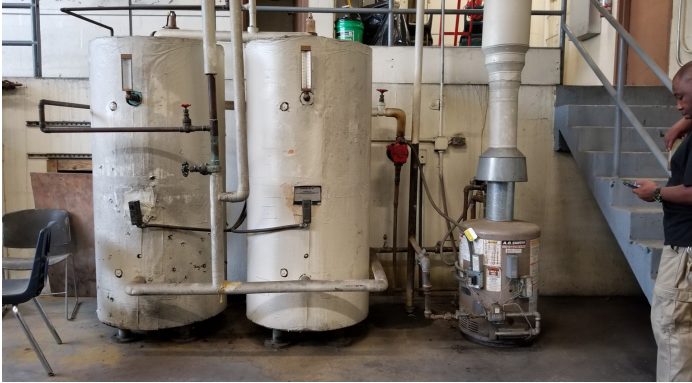
200 gallon hot water heaters

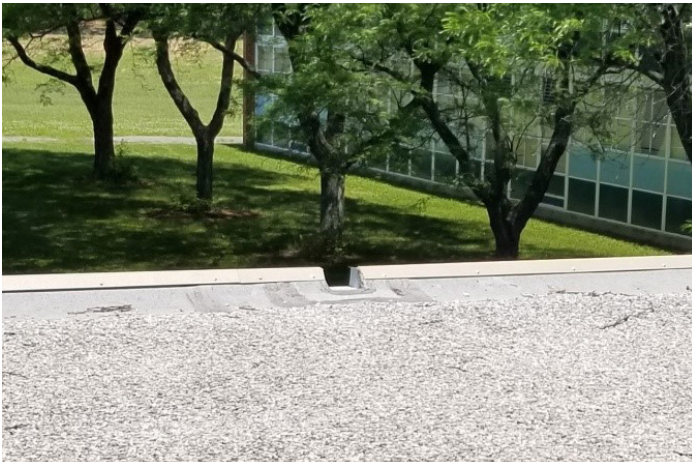
Scuppers at roof edge

All the buildings' primary storm drainage system consists of roof drains. Emergency overflow drainage is accomplished through over flow scuppers. There were no reports by school staff of leaking problem for all the buildings until current raining period. A little leaking was found at CVPA building.

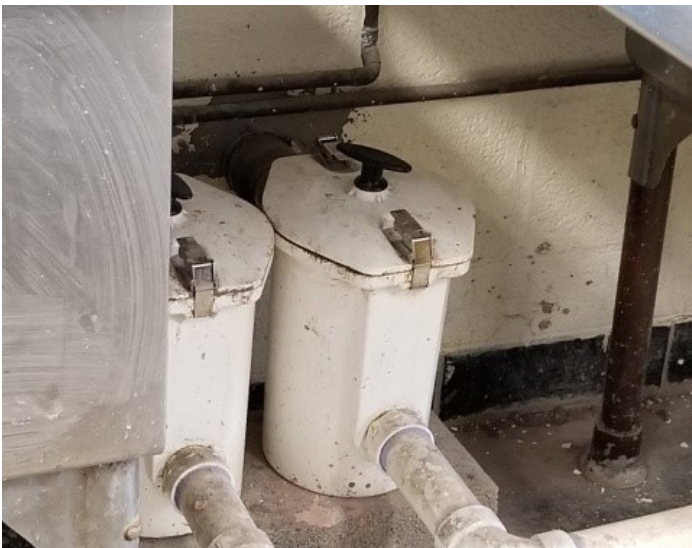
Clay traps at visual arts class

very dirty.

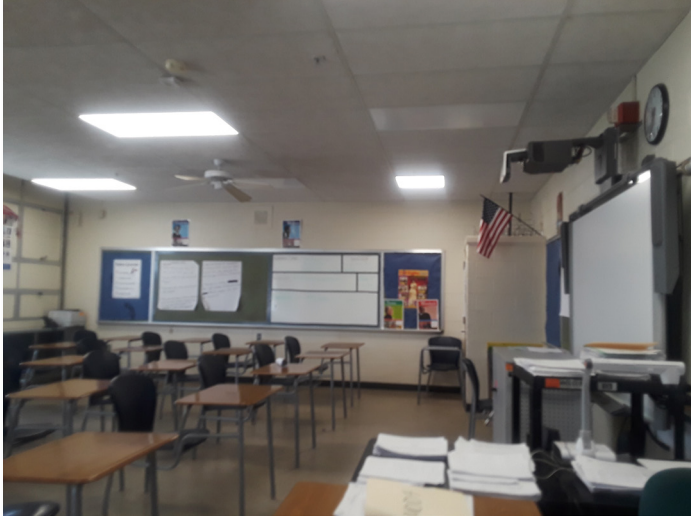
Typical classroom

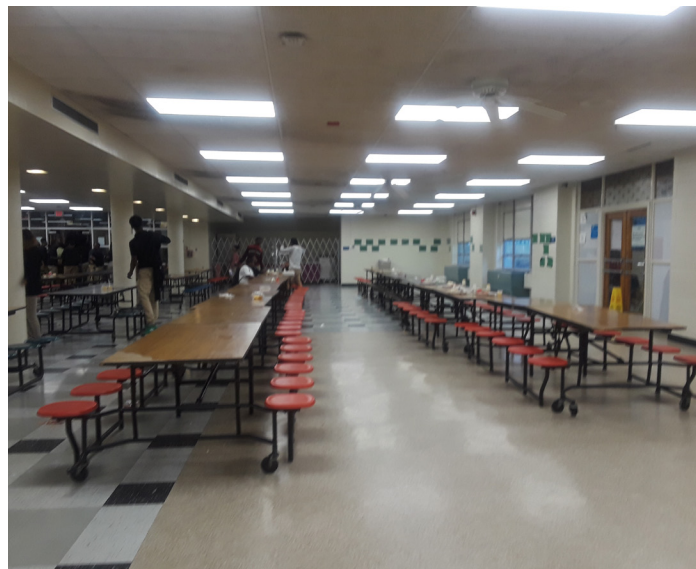
The cafeteria is also located near the Brooks Drive entrance and is a half story below the entrance level directly below the gym. There is one serving area in which two lines are formed during the lunch period. Flooring and mobile tables with integral seats are in good condition. Ceiling fans in the space are in fair condition. The kitchen area consist of a main food prep area, storage area and locker area. Some boxes were being stored in the circulation areas in addition to the storage rooms. Flooring in the kitchen area is in fair condition.

*Cafeteria***Auditorium**

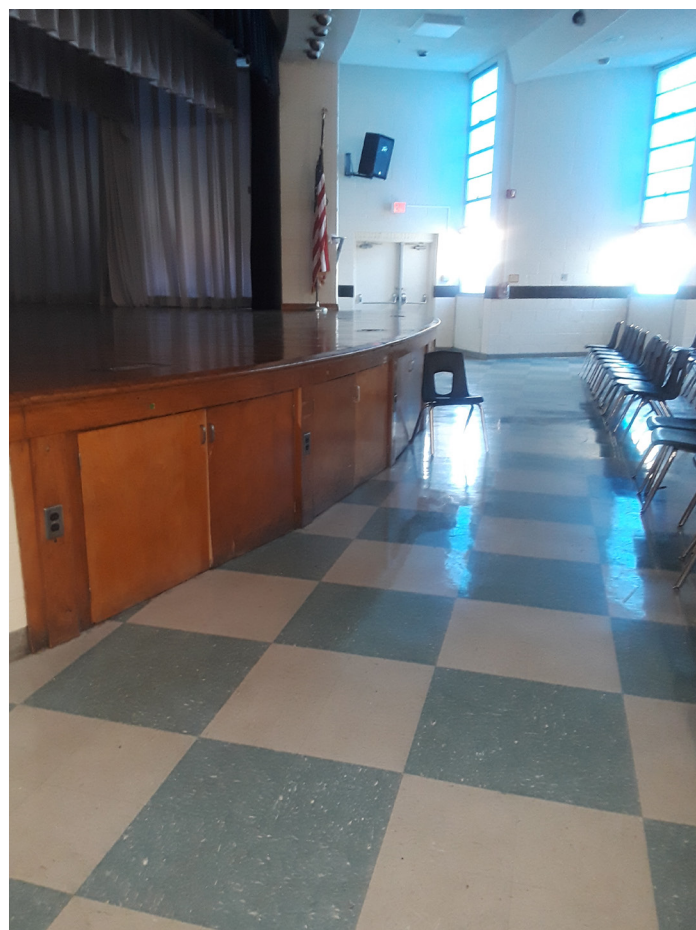
The auditorium is a double height space with room for about 320 non fixed seats. There is a small balcony area that is generally locked and not used for seating. The stage is in fair condition and is about 3' above the seating level. Access doors to storage under the stage show signs of wear with some areas of missing veneer. The walls are painted CMU block and are in good condition. The gypsum ceiling and VCT flooring are also in good condition.

*Stage in auditorium*

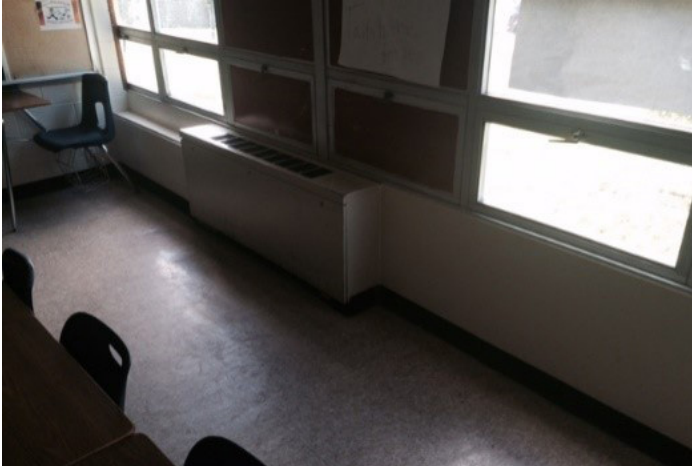
Typical classroom FCU

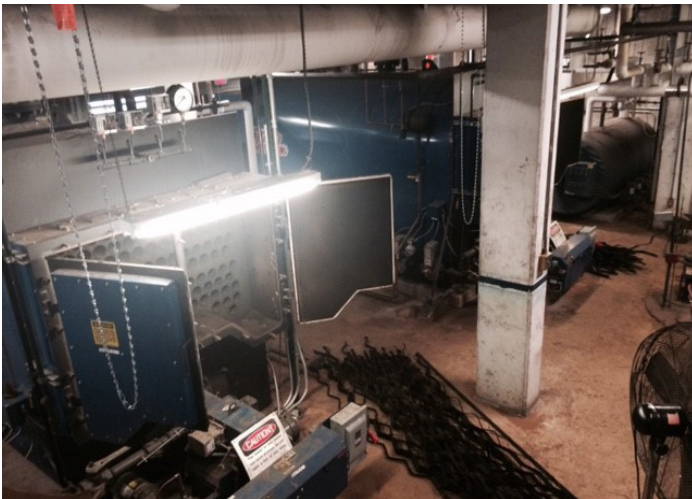
Firebox heating water boilers

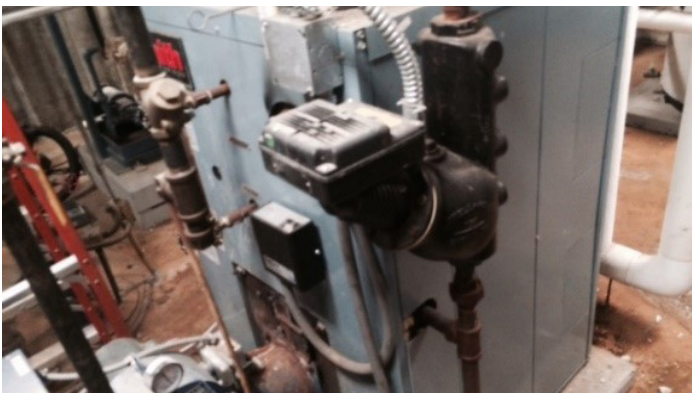
Cast iron kitchen boiler

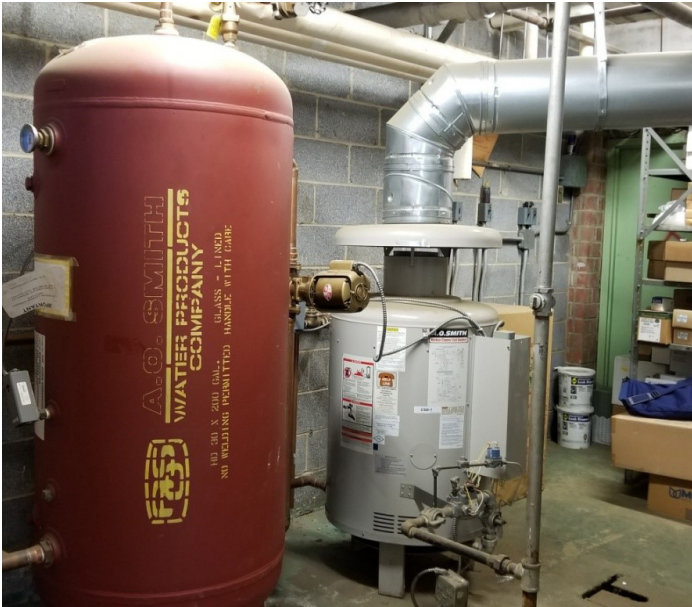
Electric domestic water heater

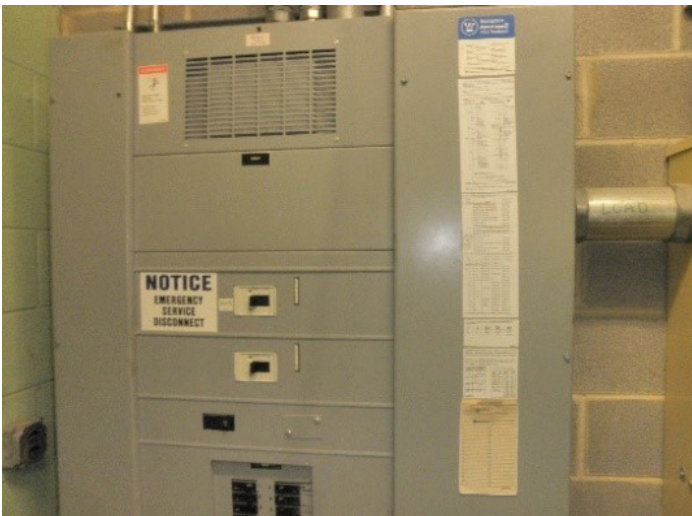
Emergency generator panel EMDP

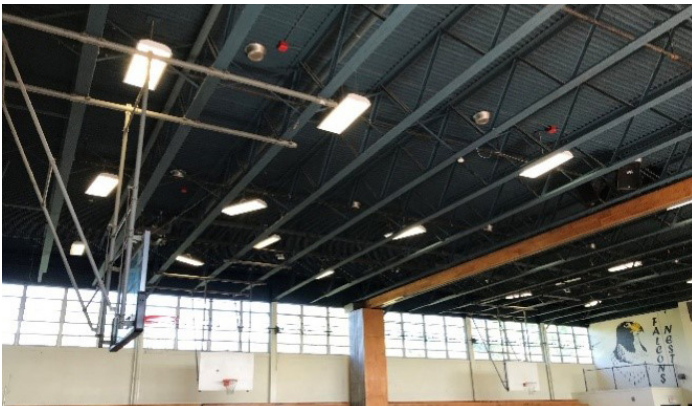
2x4 fixtures in gym
